# INSTALLATION RESTORATION PROGRAM

## REMEDIAL INVESTIGATION REPORT ADDENDUM FOR IRP SITE NO. 6

161st AIR REFUELING GROUP  
ARIZONA AIR NATIONAL GUARD  
SKY HARBOR INTERNATIONAL AIRPORT  
PHOENIX, ARIZONA

MAY 1996

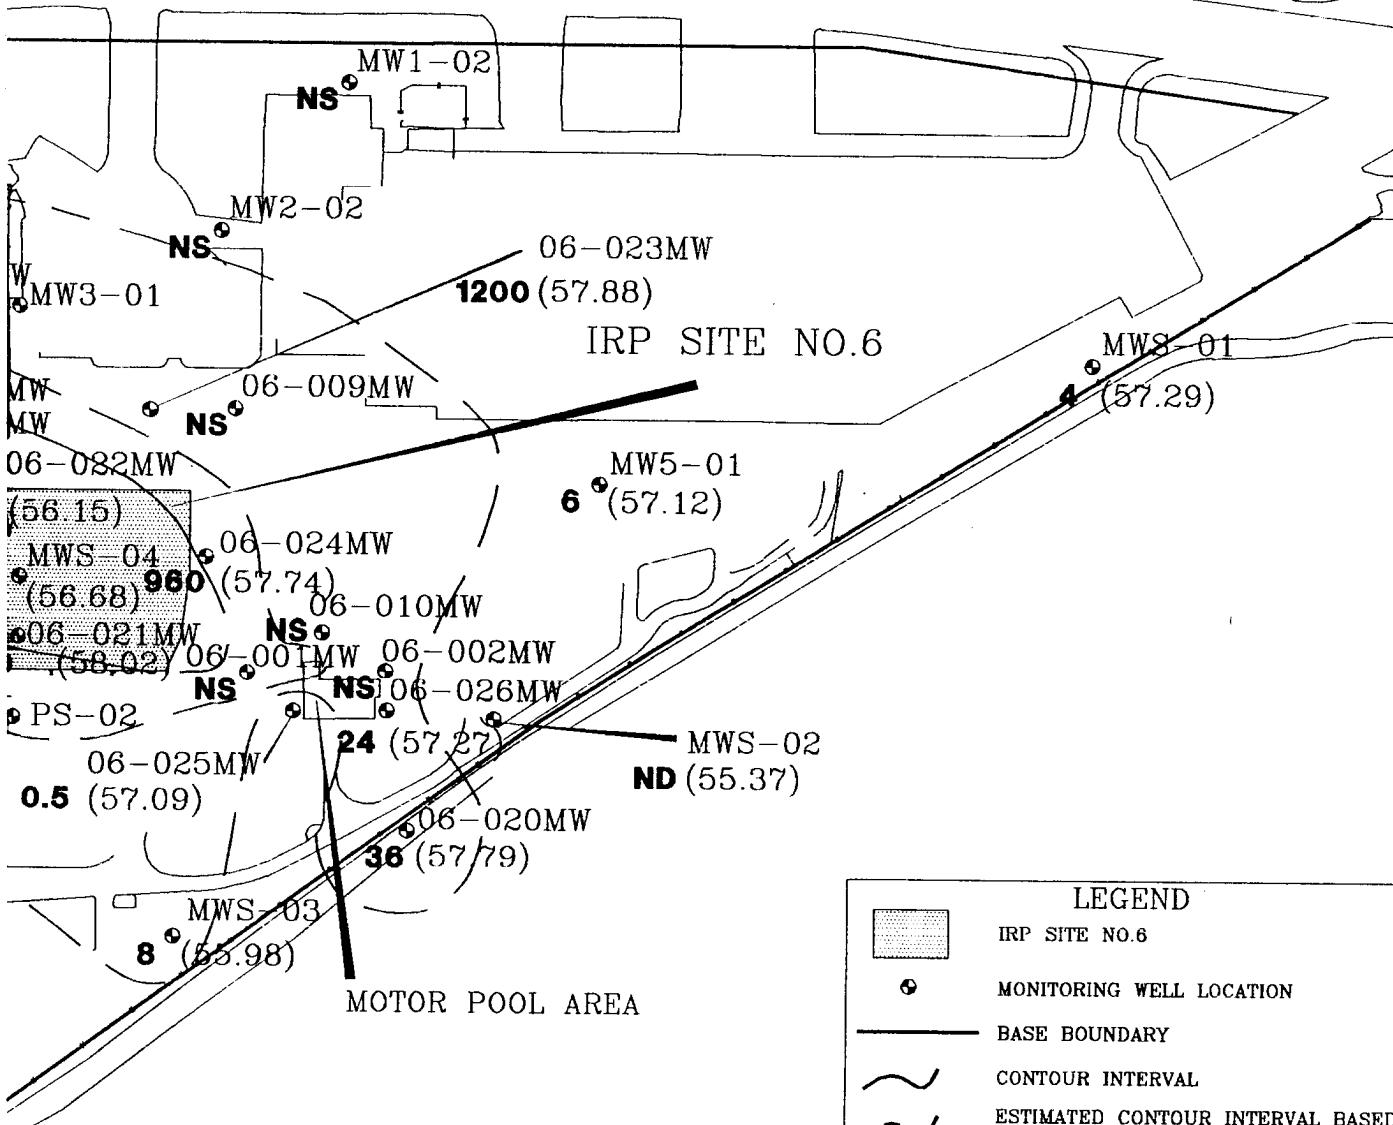
FIGURE 5.4

Groundwater analytical results indicate that VOC contamination has migrated approximately 2,100 feet downgradient from IRP Site No. 6. Contamination has also been detected upgradient at the motor pool area. Contamination was detected in monitoring wells 06-020MW, 06-025MW, 06-026MW, and MWS-03. MWS-03 has had a history of groundwater contamination and is located downgradient of the motor pool area as is 06-025MW. Monitoring well 06-020MW is located cross-gradient of the motor pool area. Monitoring well 06-029MW is located immediately upgradient of the motor pool area.

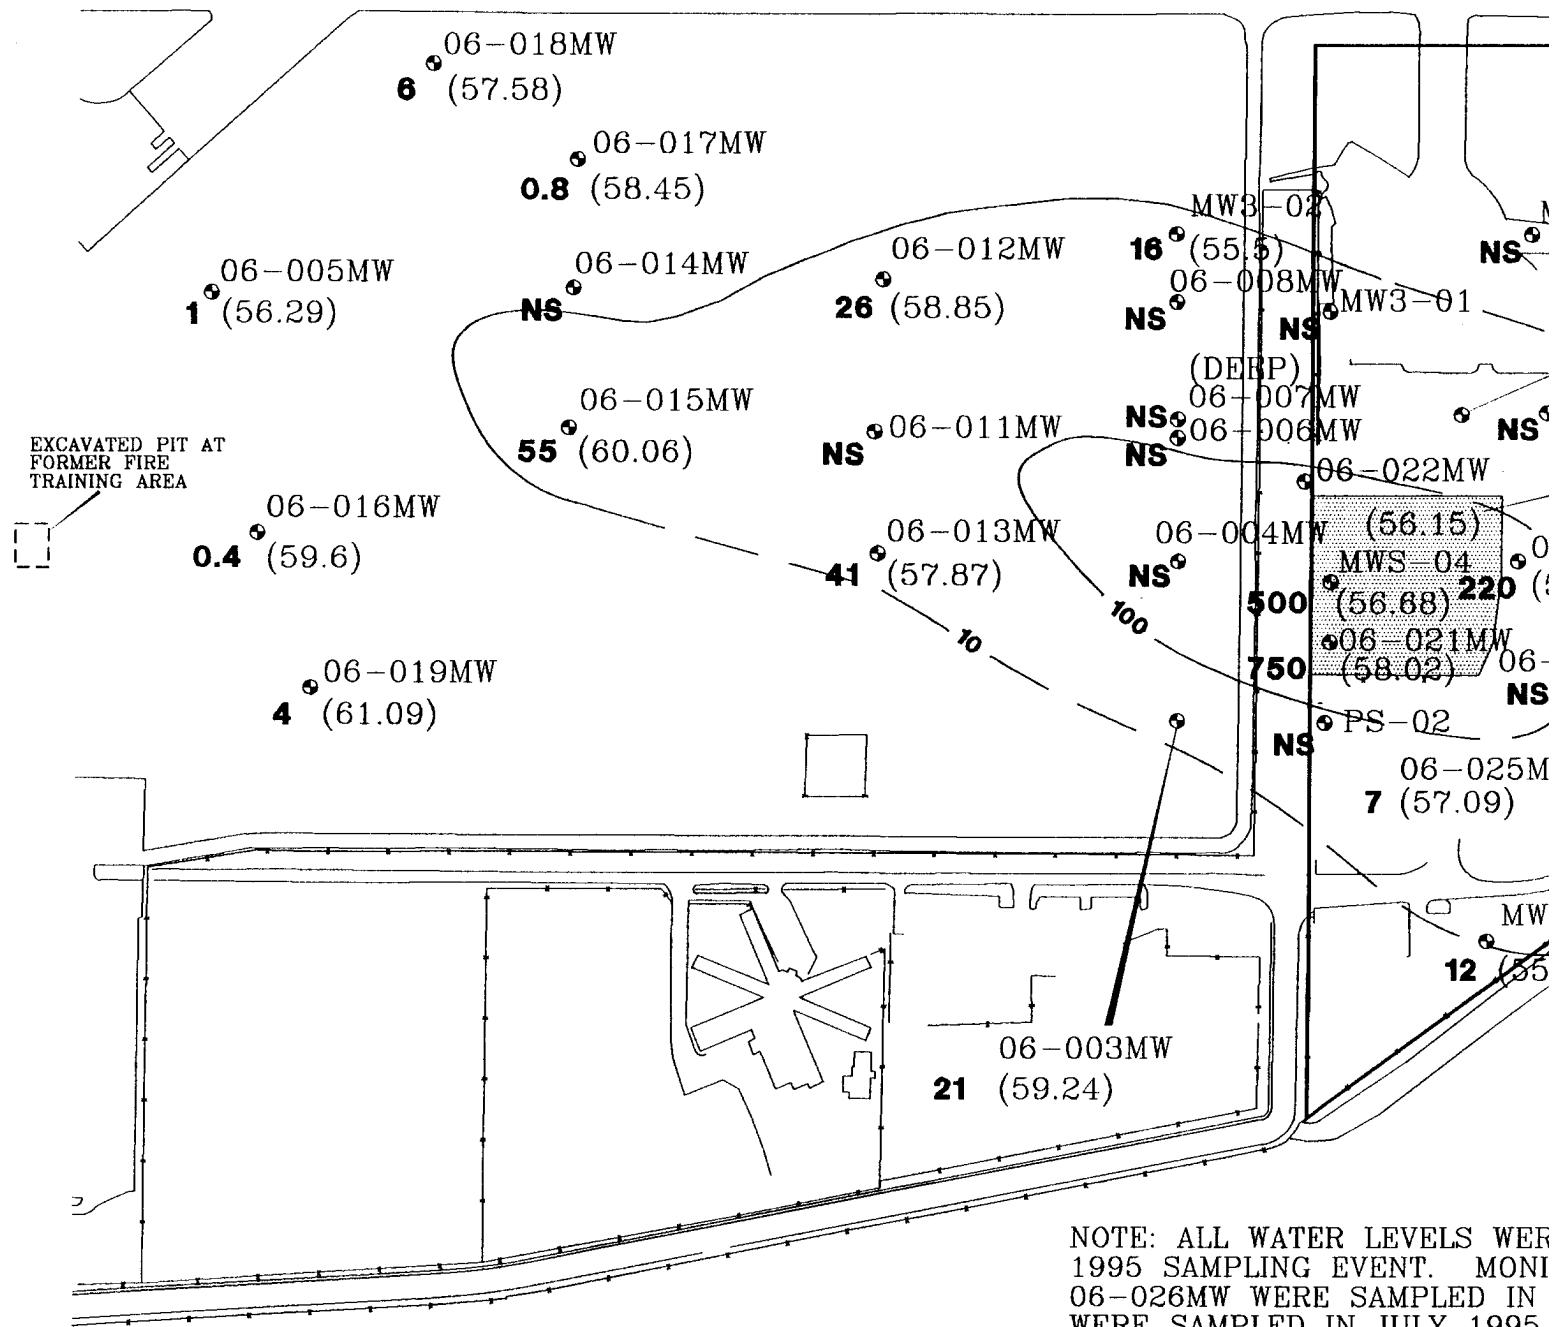
## FIGURE 5.6

Ethylbenzene was detected at concentrations ranging from 0.4 to 750  $\mu\text{g}/\text{L}$ , exceeding the ADEQ action level of 700  $\mu\text{g}/\text{L}$  in the groundwater sample collected from monitoring well 06-021MW. Ethylbenzene concentrations detected in groundwater samples collected during the July – August 1995 sampling event and the January 1995 sampling event are presented as Figures 5.6 and 5.7, respectively.

ETHYLBENZENE DETECTED  
(10-14 JULY AND 8-10  
GROUNDWATER SA  
161st ARG, Arizona Air Na  
Sky Harbor Internation  
Phoenix, Arizo

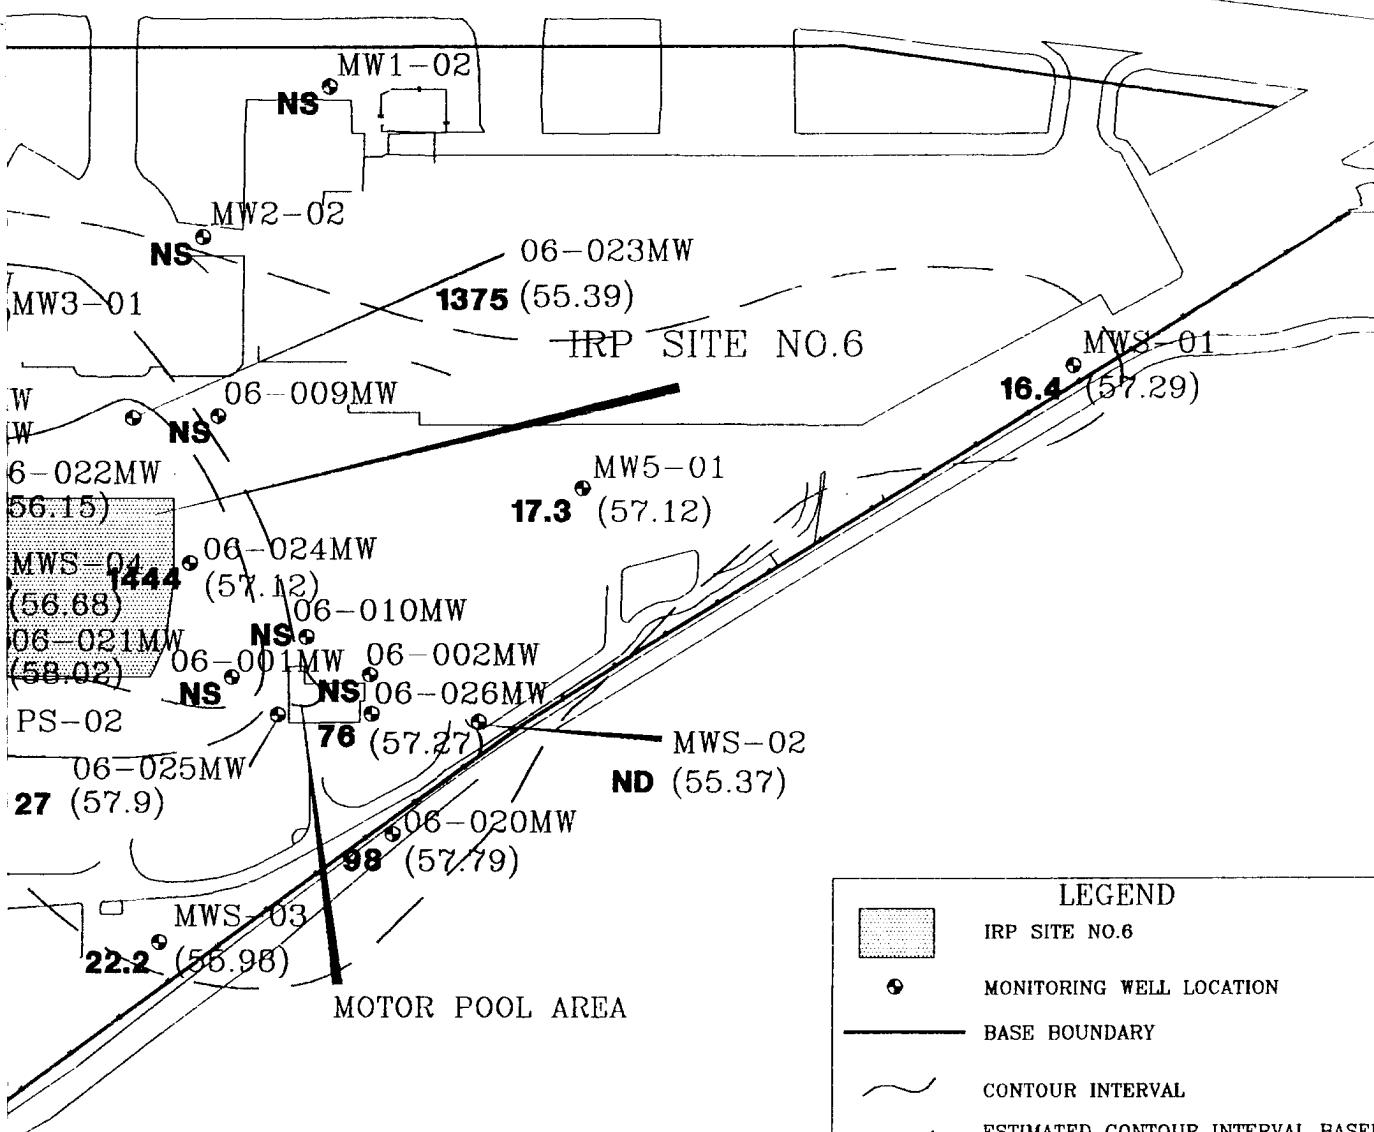
## FIGURE 5.8

Total BTEX was detected at concentrations ranging from 0.8 to 4,721  $\mu\text{g/L}$ , with the highest concentrations detected in groundwater samples collected from monitoring wells MWS-04, 06-017MW, 06-021MW, 06-022MW, 06-023MW, and 06-024MW. Total BTEX concentrations detected in groundwater samples collected during the July – August 1995 sampling event and the January 1995 sampling event are presented as Figures 5.8 and 5.9, respectively.

**TOTAL BTEX DETECTED IN  
(10-14 JULY AND 8-10  
GROUNDWATER SA  
161st ARG, Arizona Air Na  
Sky Harbor Internation  
Phoenix, Arizo**

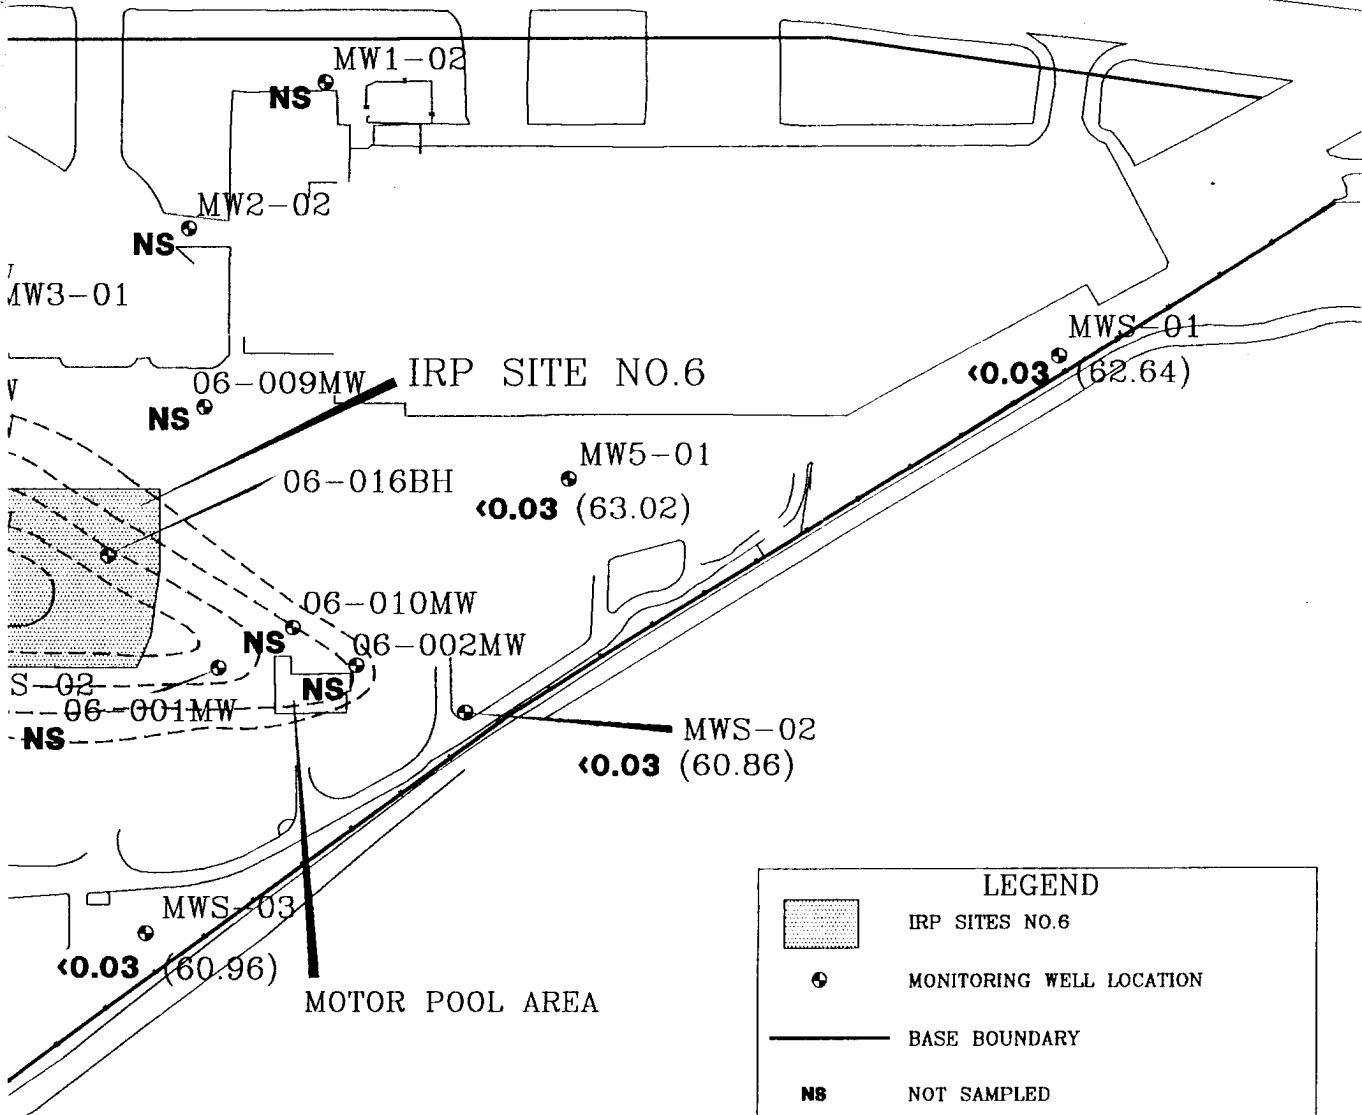
## FIGURE 5.9

# TOTAL BTEX DETECTED IN GROUNDWATER SAMPLING 161st ARG, Arizona Air National Guard, Sky Harbor International Airport, Phoenix, Arizona

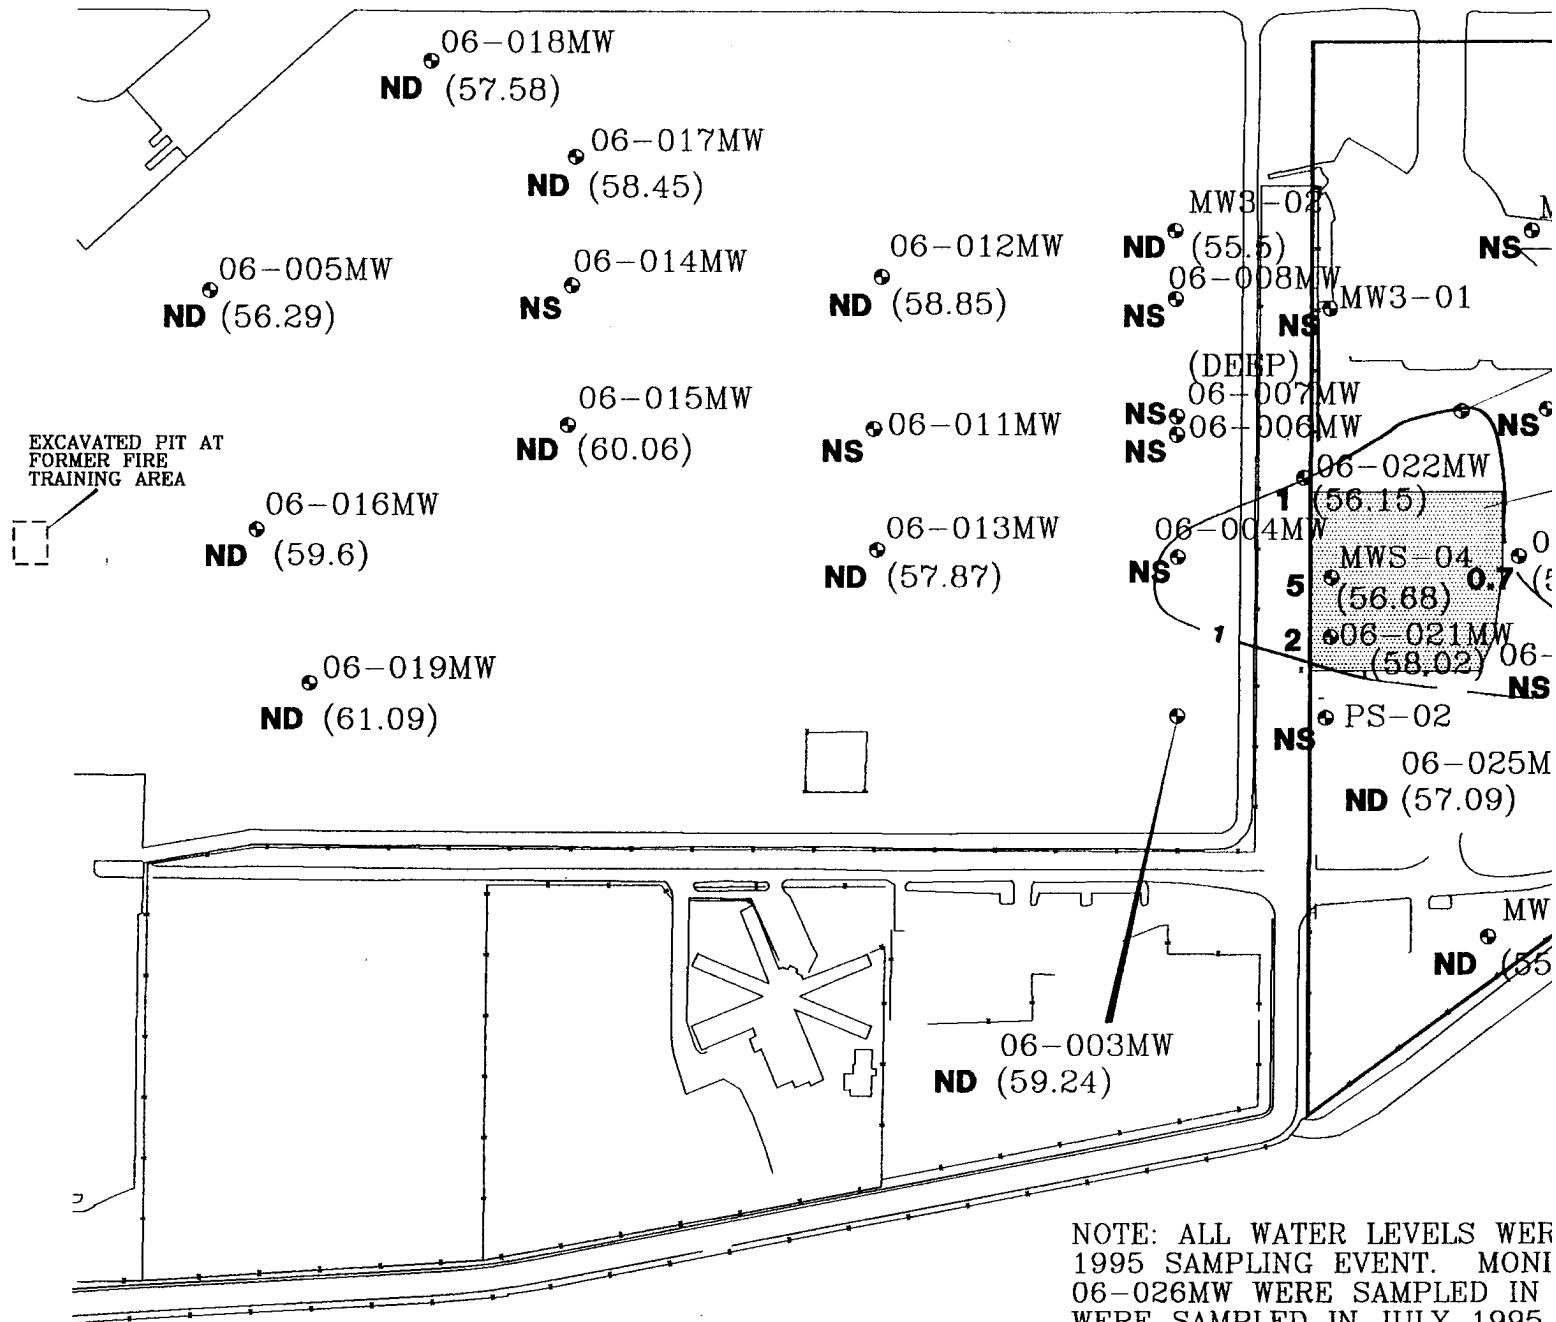
FIGURE 5.10

TPH was detected at concentrations ranging from 1 to 6 ppm in groundwater samples collected from monitoring wells MWS-04, 06-21MW, 06-022MW, 06-023MW, and 06-024MW. TPH concentrations detected in groundwater samples collected during the July – August 1995 sampling round is presented as Figure 5.10.

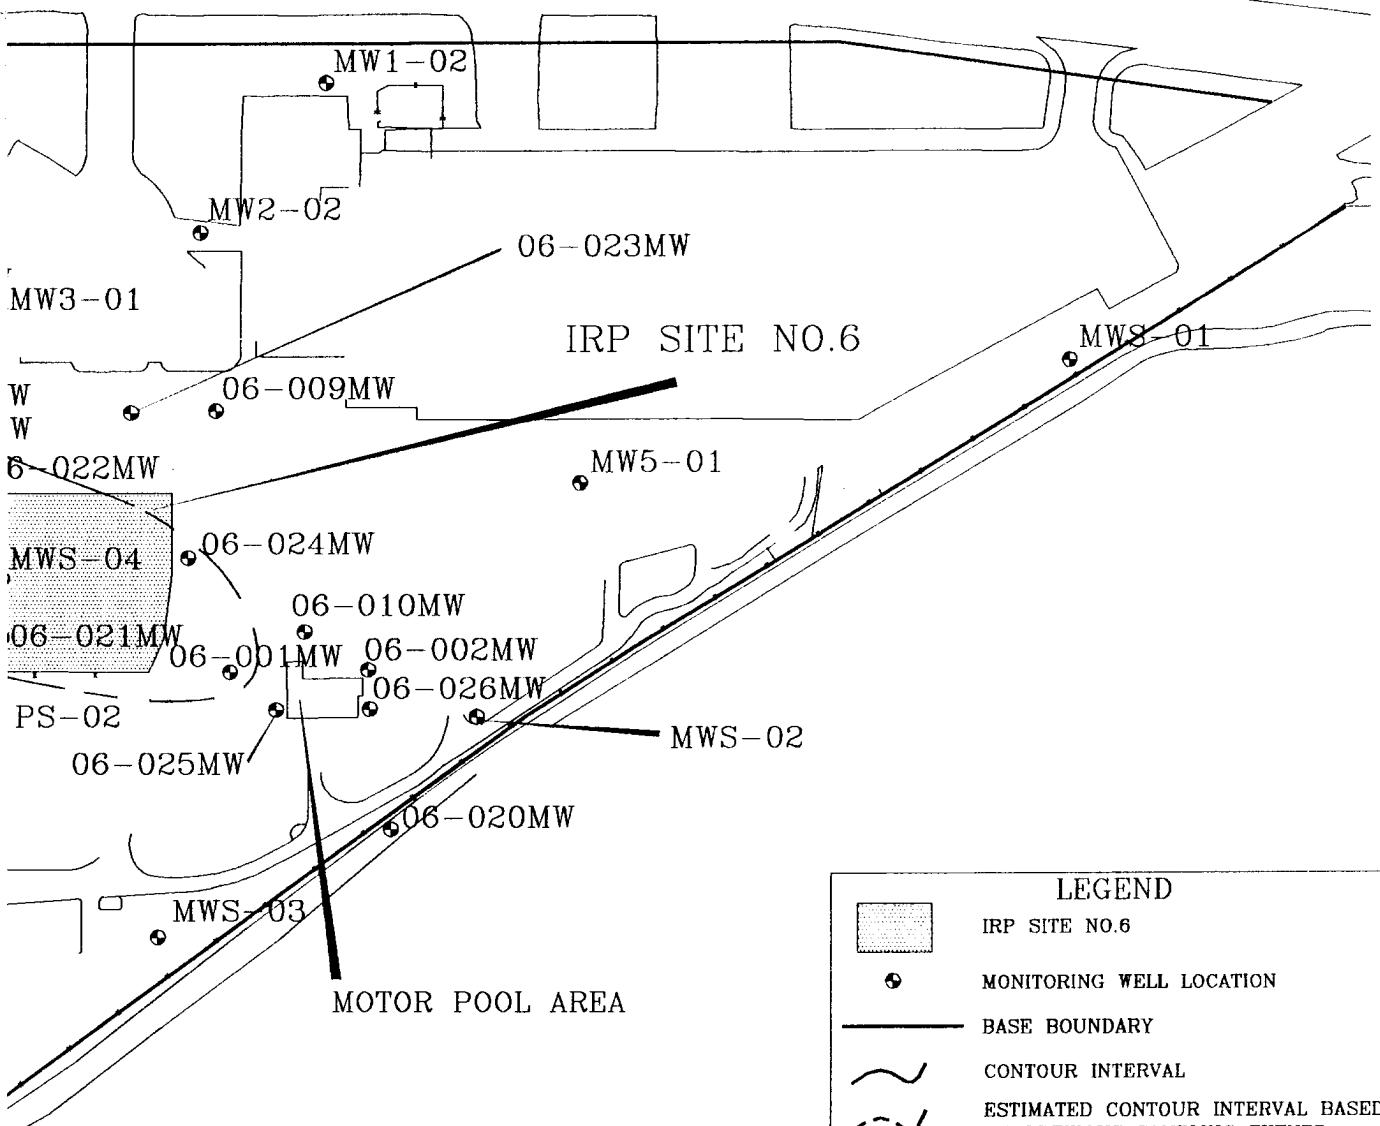
FIGURE 6.1

Monitoring well lithologic logs indicate that within this smear zone, lithology varies from gravels to sands with varying amounts of clays, silts, and very fine sands. Contamination will adhere to finer material in larger amounts because the finer materials have more surface area. Based upon GC analyses of soil samples collected while drilling, the smear zone was observed in monitoring wells 06-004MW, 06-006MW, and 06-007MW which are located directly downgradient of the POL Storage Area. Based upon this data, the thickness of the smear zone is approximately 20 feet. The estimated areal extent, base upon gas chromatograph analysis of soil samples, is depicted on Figure 6.1.
